Desmond's C64/MAX RAM Test Thing

(DesTestMAX – Licensed Version for AmericanRetro.Shop)

Matthew Desmond

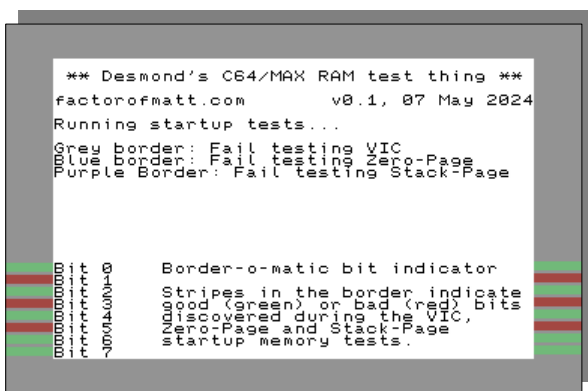
VIC Test Failure

A failure during the VIC test results in a grey border with the failing bits displayed in the bottom part of the screen:

The border-stripes show data bits (D0-D7, top to bottom) that showed inconsistencies while testing the VIC-II registers. Here we see that data bits 1, 3 and 5 were detected as bad. This may be of diagnostic use if another data attached chip in the system is corrupting the bus – or it may simply indicate a marginal VIC-II.

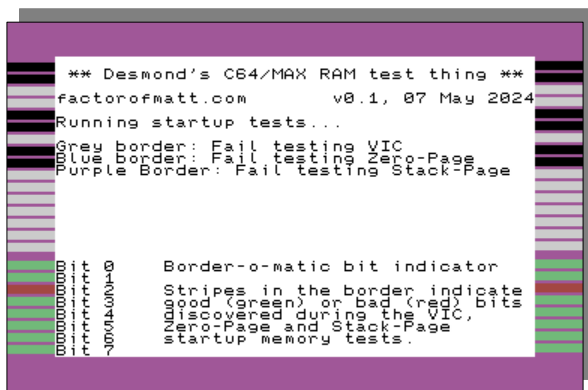
Zero Page or Stack Page Failure

A failure during either of these tests results in a blue (zero-page) or purple (stack page) border plus stripes indicating the fail-address and failed bits:

The border stripes show address bits (A0-A15, top-to-bottom) and data bits (D0-D7, top to bottom). A black address bit is 1, light grey is 0. A green data bit indicates a good bit, red indicates bad. Here we see that data bit 2 was detected as bad and that the most recent memory location found to be bad was \$01B3.

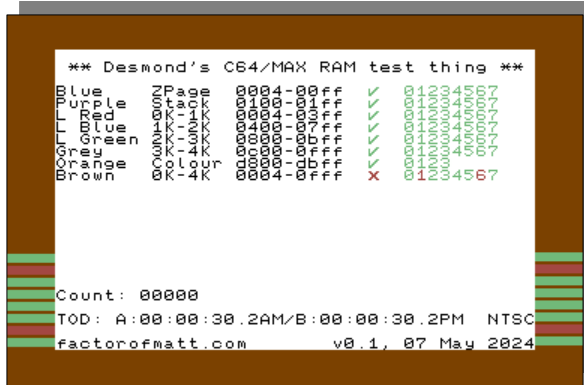
Error Detected, No information saved

If no error information was collected, the border stripes show data bits (D0-D7 top to bottom) green for good, red for bad.

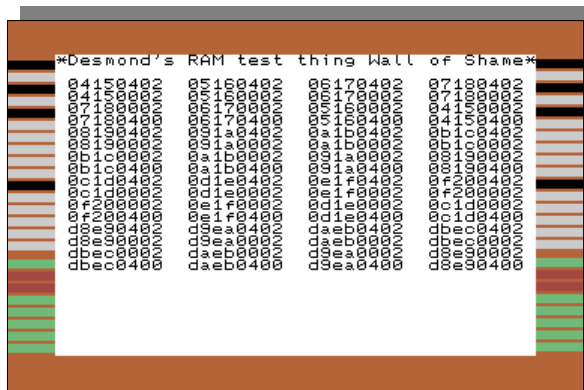
Error Detected, Information saved.

In the event that we were able to collect some address/bit-error information it is displayed on the following screen. Each error record is 8 hex digits wide:

- First 4 digits: The address at which an error was detected
- Next 2 digits: An indication of bits that were written as 0 but were read as 1
- Last 2 digits: An indication of bits that were written 1 but were read as 0

An error record of 04150402 indicates that at address \$0415 bit 2 (\$04) was mistakenly read as 1 and bit 1 (\$02) was mistakenly read as 0. Patterns may emerge both in addresses and bad bits that can indicate the source of problems.

Note: some addresses may appear multiple times since the testing algorithm walks through memory both backwards and forwards a couple of times each.
